TECHNICAL REPORT REMR-CO-3

CASE HISTORIES OF CORPS BREAKWATER  
AND JETTY STRUCTURES

Report 8

LOWER MISSISSIPPI VALLEY DIVISION

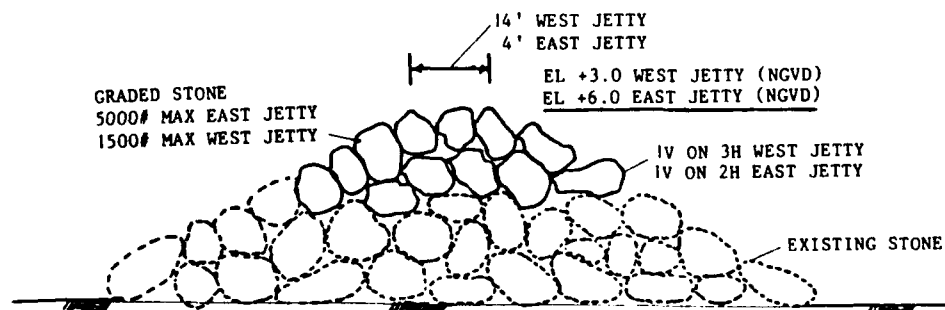
c. Jetty repair, 1984

1984	<p>Repairs were made on the seaward end of the west jetty for a distance of 4,550 ft, and the entire east jetty was repaired (Figure 6c). (These were called repairs even though the original design called for two-phase construction.) Existing (1983 survey) center-line elevations on sections to be repaired were from +1 to +3 ft National Geodetic Vertical Datum (NGVD) on the west jetty and from +2 to +5 ft NGVD on the east jetty. (NGVD datum is about 0.5 ft above mlg datum).</p>

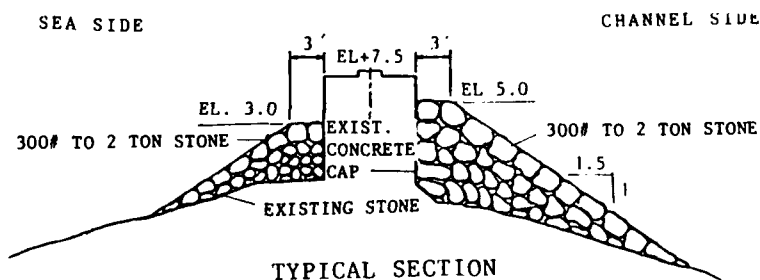
Figure 10. Stone buttressing of the concrete cap on the South Pass east jetty, 1966

1966	The east jetty concrete cap was buttressed with stone (Figure 10) along 3,800- and 6,700-ft-long sections on the sea and channel sides,

Date(s)	Construction and Rehabilitation History
1966 (cont.)	respectively, both sections terminating at the seaward end. The 300-lb to 2-ton stone was placed to +3 and +5 ft mlg on the sea and channel sides, respectively, with a berm width of 3 ft and 1V:1.5H side slopes. A total of 38,300 tons of stone was placed at a cost of \$264,000.
1970- 1971	Two sections of the east jetty were repaired and a 100-ft-long jetty tie-in constructed. A 650-ft section of the concrete cap, located about 5,400 ft from the seaward end, was buttressed with stone. The design geometry was identical to that used in 1966 repairs (Figure 10). A 300-ft section and tie-in section, located 6,900 and 8,500 ft from the outer end, respectively, were built up to +7.5 ft mlg, with a 6-ft crown width and 1V:1.5H side slopes. The repairs were made with 300-lb to 2-ton stone, and a 1-ft-thick layer of shell was placed as bedding for the jetty tie-in. A total of 16,500 tons of stone and 500 cu yd of shell was used for an approximate total cost of \$164,000.

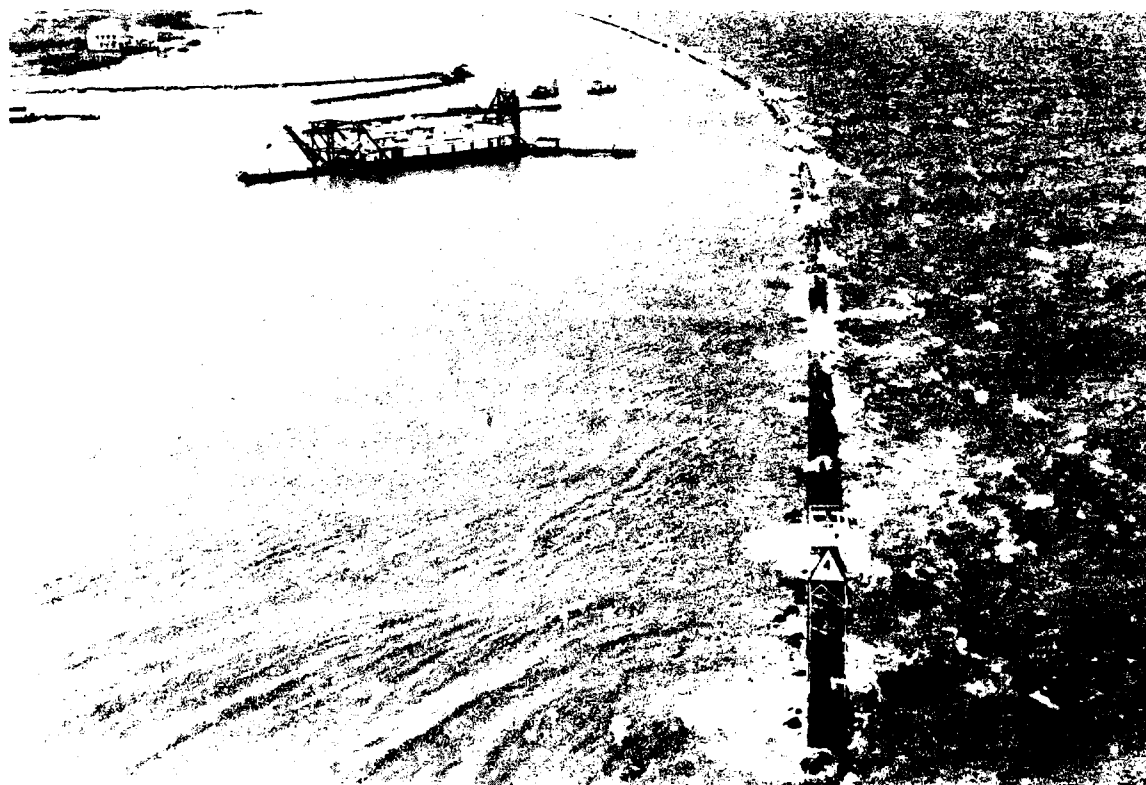
Figure 11. East jetty at South Pass, 1977

1985	No new work has been done since 1971, and the project has been essentially inactive since 1978. All deep-draft traffic now uses Southwest Pass. Figure 11 is a 1977 photograph of the east jetty.

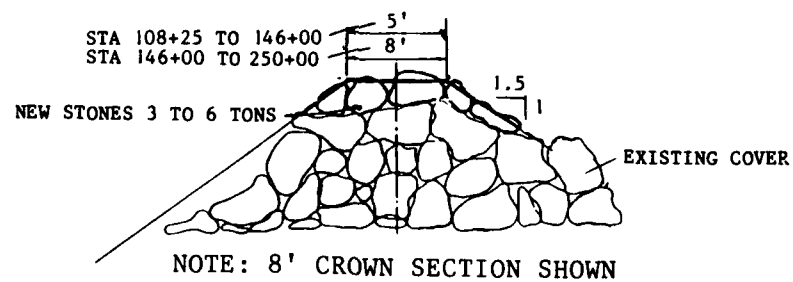
b. Typical repairs made during the 1970's

1972	The east jetty was repaired from 140+00 to 167+00 using 3- to 6-ton armor stone. The design geometry (Figure 13b) specified a +6 ft mlg crown elevation, 5- and 8-ft crown widths shoreward and seaward of 146+00, respectively, and 1V:1.5H side slopes. An April survey (before repairs) of the jetty showed an average center-line elevation of +2.5 ft mlg within the repair area, and +3 ft mlg elsewhere. Cost of the repairs was \$349,000 using 36,900 tons of stone.
1974	Two sections of the east jetty were repaired using the 1972 design geometry and stone size (Figure 13b). Crown widths were 5 ft, from 117+00 to 140+00, and 8 ft from 167+00 to 204+50. Cost of the repairs was \$1,399,000 using 64,500 tons of stone. Figure 15 is a photograph taken in February showing three dredges operating between the jetties and a grounded vessel near the seaward end.
1975	The east jetty was repaired with 3- to 6-ton stone at locations 140+00 to 158+50 and 204+50 to 249+45 (seaward end). The design geometry (Figure 13b) had an elevation of +6 ft mlg, 1V:1.5H side slopes, and an 8-ft-wide crown (except from 140+00 to 146+00 which was 5 ft wide). After repairs were completed, it was noted that additional stone between 204+50 and 249+45 would be needed to stabilize the gulf side slope because some of the new slope stones were removed during periods of heavy wave action. The total cost was \$2,306,800, and 103,660 tons of stone were required.

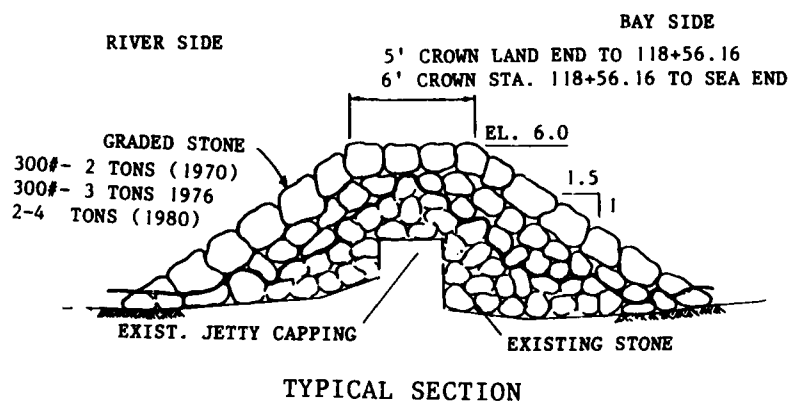
c. Typical repairs made during 1970-1980

1980	Two sections of the west jetty were repaired (Figure 14c) with armor stone (possibly 2- to 4-ton size). The crown elevation was +6 ft mlg, and the side slopes were 1V:1.5H. The landward section, from 20+00 to 63+00, had a 5-ft crown width; and the seaward section, from 123+00 to 142+40, had a 6-ft crown width. Prior to repairs, an April 1979 survey showed center-line elevations averaging +4 ft mlg within the repair areas and from +4 to +7 ft mlg over the remainder of the jetty. Total cost of the repair work was \$1,104,300 using approximately 43,000 tons of stone.
1981- 1982	The landward and seaward ends of the east jetty were repaired (Figure 13b) with armor stone (possibly 2 to 4 ton size) at the following locations: 108+25 (landward end) to 150+30, 155+70 to 165+40, and 217+55 to 250+00 (seaward end). The design geometry had a +6 ft mlg crown elevation, 1V:1.5H slide slopes, and crown widths of 5 ft (landward of 146+00) and 8 ft (seaward of 146+00). Prior to repairs, center-line elevations (September 1980 survey) varied from +4 to +6 ft mlg along the landward sections, from -2 to +6 ft mlg on the seaward section, and from +5 to +7.5 ft mlg elsewhere. Total cost of the repairs was \$820,000 using 37,500 tons of stone.
